## **Screw Replacement Procedure of Itron RIVA CAM Module on IR8140 Router**

Revised: August 29, 2023,

The procedure provided in this document is to establish the alternate procedure for replacing the alignment pin and lock washer with screw in Cisco IR8140 router.

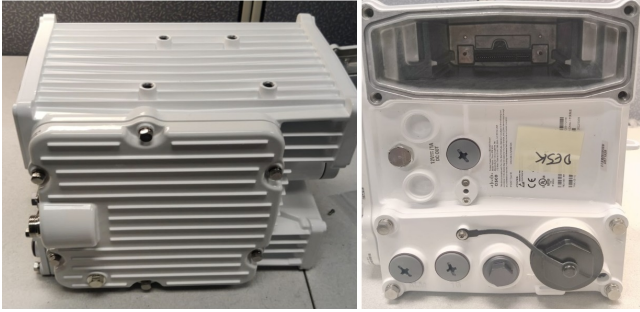
Step No.	Step Description	Failure Mode	Remarks
1	Place the IR8140 in the fixture. (In horizontal orientation)

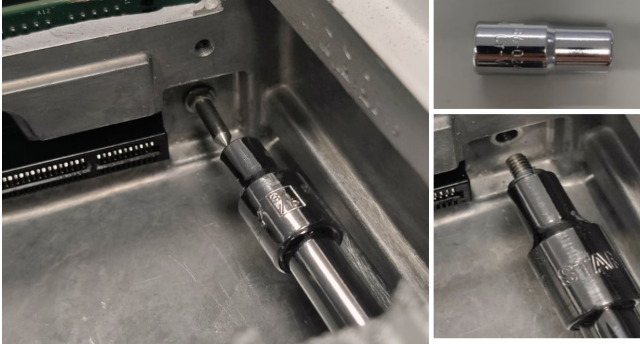
—	—
2	Use 3/16 socket driver as shown to remove the alignment pin and washer. The washer is intended to come off with the alignment pin.

The socket might hit the connector in the slot.	<ul style="list-style-type: none"> <li>• Make sure alignment pin and washer is removed.</li> <li>• Do not disturb or hit any other components.</li> </ul>
3	Check to see the washer is removed. If not, use a magnetic retriever to remove the washer.

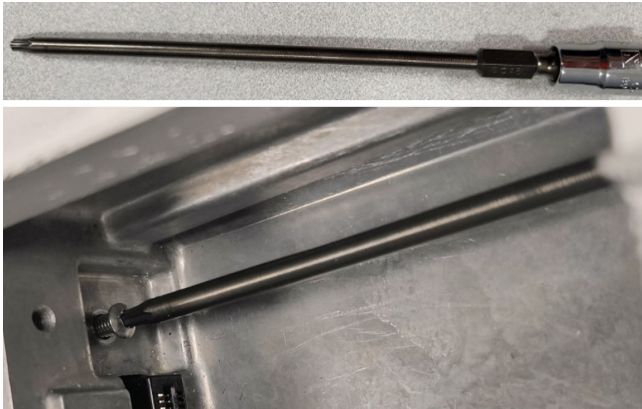
Step No.	Step Description	Failure Mode	Remarks
5	<p>Use Torx screwdriver to assemble the screw inside the cavity to 8-10 in.lbs torque.</p>

<ul style="list-style-type: none"> <li>• Screw is not properly seated.</li> <li>• Screw is cross threaded.</li> <li>• Screwdriver might hit the connector in the slot.</li> </ul>	<p>Check whether the screw is properly assembled and seated.</p>
6	<p>Inspect whether the assembly is properly done.</p>

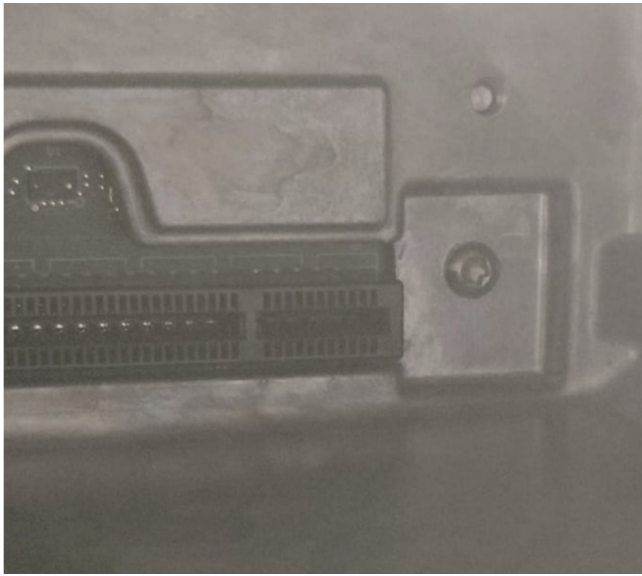
<ul style="list-style-type: none"> <li>• Damaged components</li> <li>• Unseated screw</li> <li>• Alignment pin or washer in cavity</li> <li>• Wrong alignment pin removed</li> </ul>	<ul style="list-style-type: none"> <li>• Ensure the correct alignment pin and washer was removed.</li> <li>• Ensure screw is fully seated.</li> <li>• Ensure no damage components.</li> </ul>
