## TEST REPORT

Dust Test - IP6X

Continuous Immersion Test - IPX8

Outdoor Zoom Dome with D/N / Z85

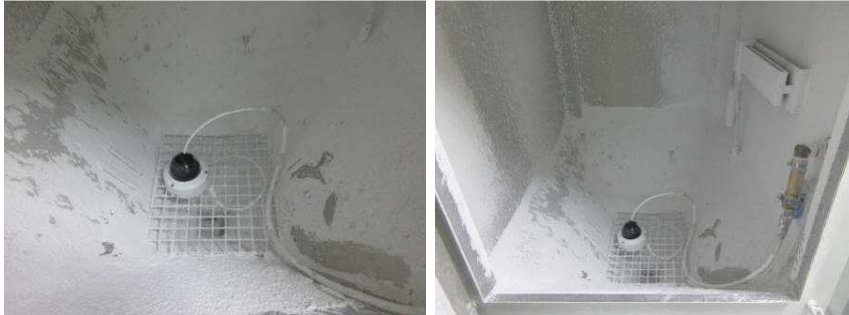
-Setup photo:

- Talcum powder size: < 0.075 mm
- The amount of talcum powder: 2 kg per cubic meter
- Under pressure: 20 mbar
- Test duration: 8 hours

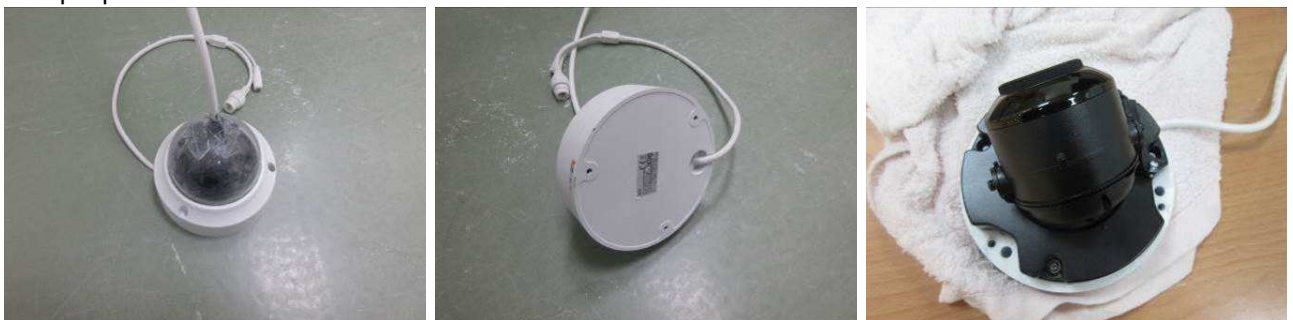
-Sample photo after the test:

- No visible damage was found on sample appearance after the test.
- Checking for the inside of tested sample after testing is conducted by the applicant per applicant's request.

No dust penetrated into tested sample.

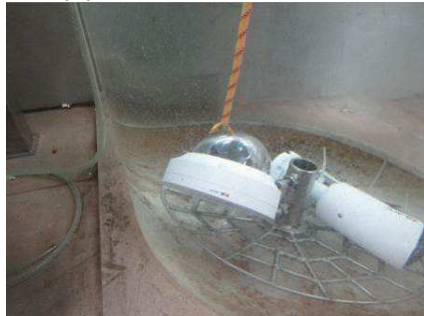
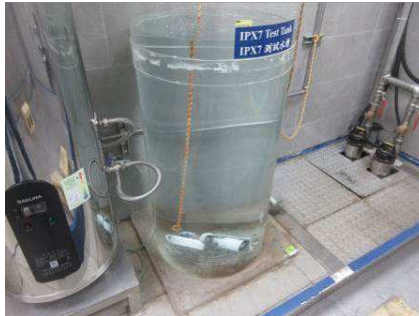
-Setup photo:

Immersion depth : 1100 mm (between the surface of the water and sample's bottom)

The duration of the test : 30 minutes

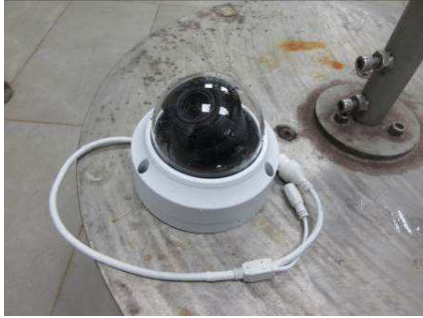
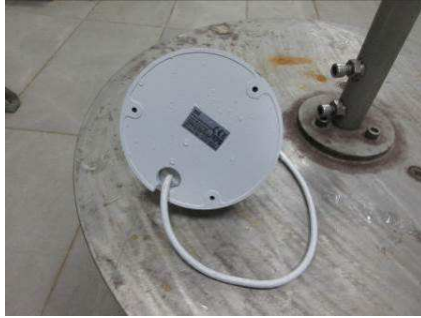
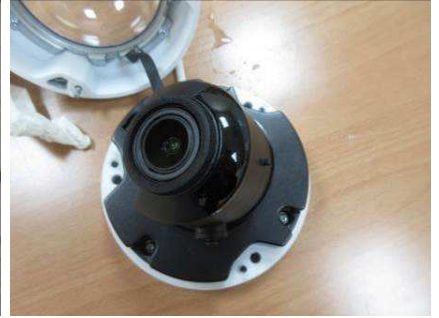
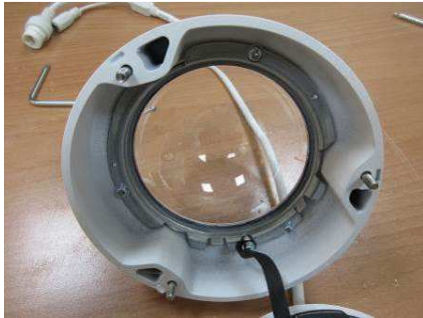
- No visible damage was found on sample appearance after the test.
- Checking of sample appearance and inside after the test was conducted by the applicant per applicant's request.
- No water penetrated into the tested sample.
- Sample photo after the test:
