IBM Flex System x240 Compute Node
Types 7863, 8737, and 8738
Installation and Service Guide

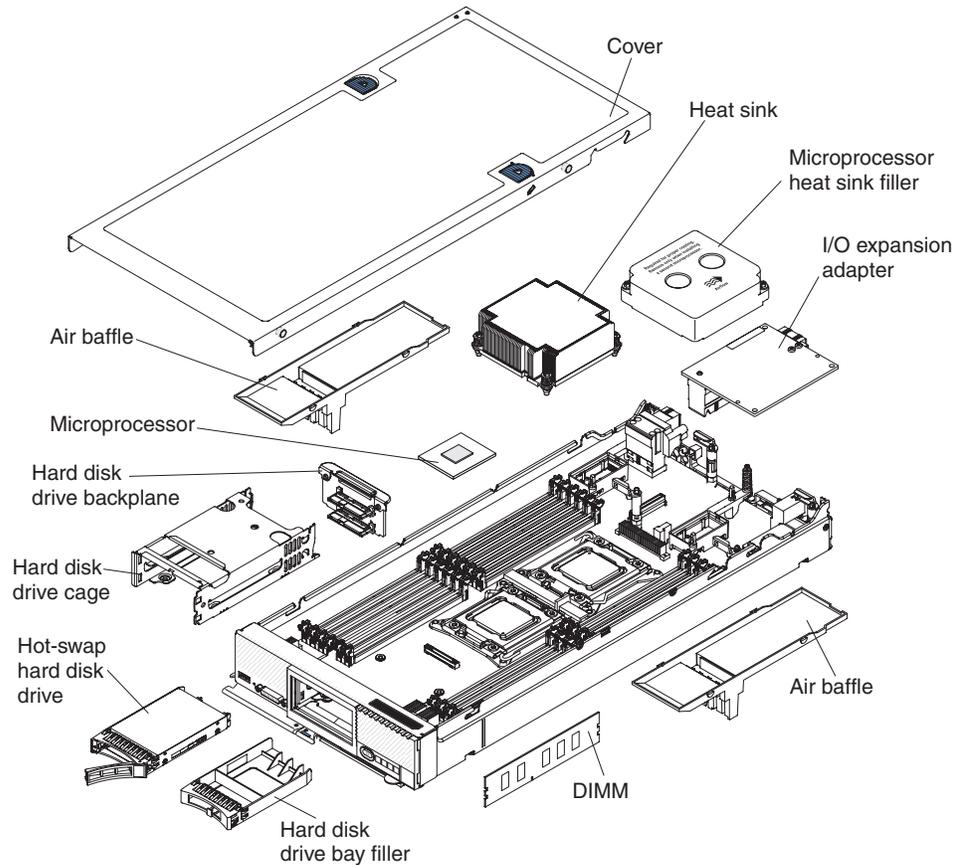
The following illustration shows the major components of the compute node.

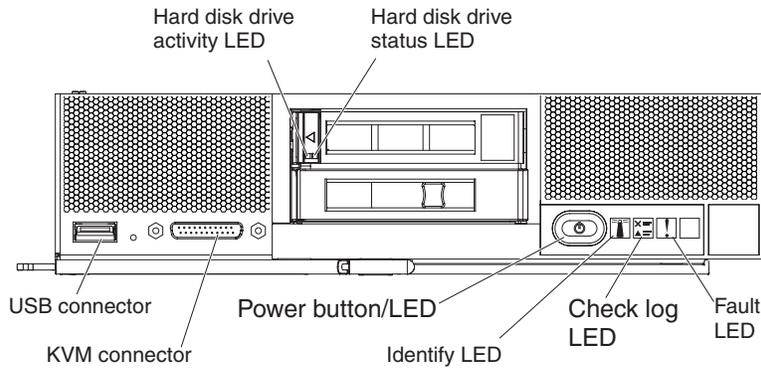
The following illustration identifies the buttons, connectors, and LEDs on the control panel.

Hard disk drive activity LED (green)

When this green LED is lit, it indicates that there is activity on the hard disk drive.

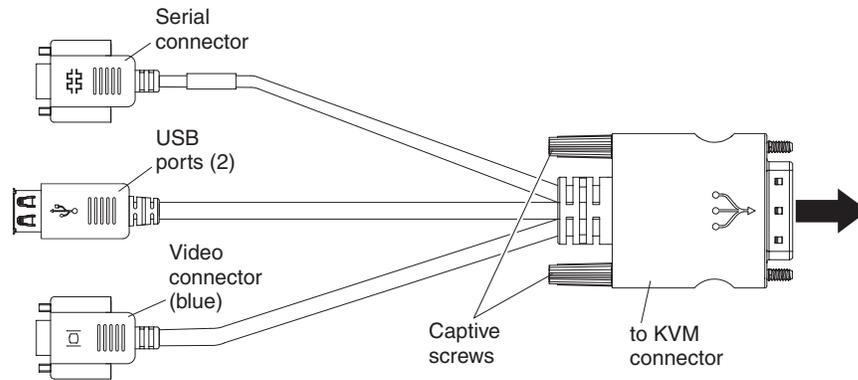
Use the console breakout cable to connect external I/O devices to the compute node. The console breakout cable connects through the KVM connector (see “Compute node controls, connectors, and LEDs” on page 9). The console breakout cable has connectors for a display device (video), two USB connectors for a USB keyboard and mouse, and a serial interface connector.

The following illustration identifies the connectors and components on the console breakout cable.

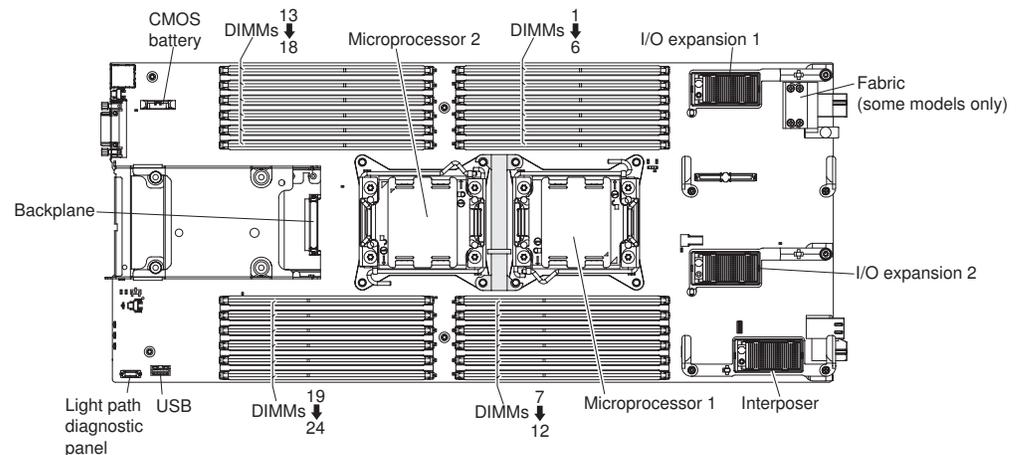
The following illustration shows the system-board components, including connectors for user-installable optional devices, in the compute node.

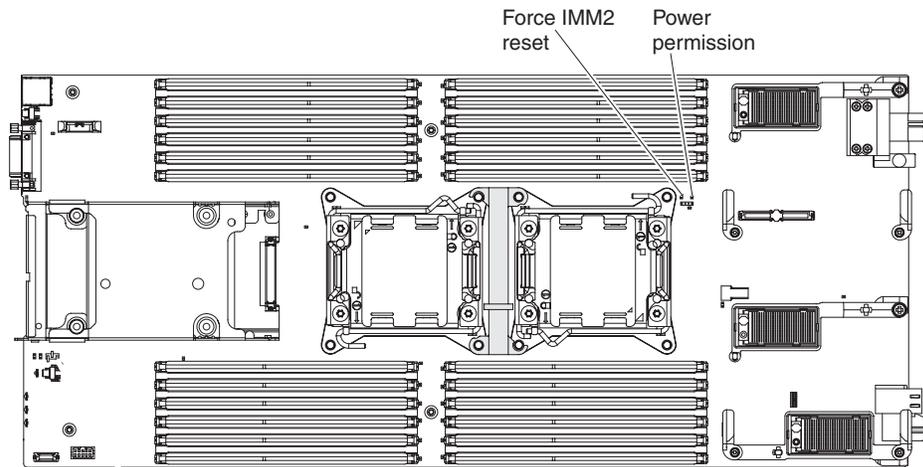
The following illustration shows the locations of the jumpers on the system board.

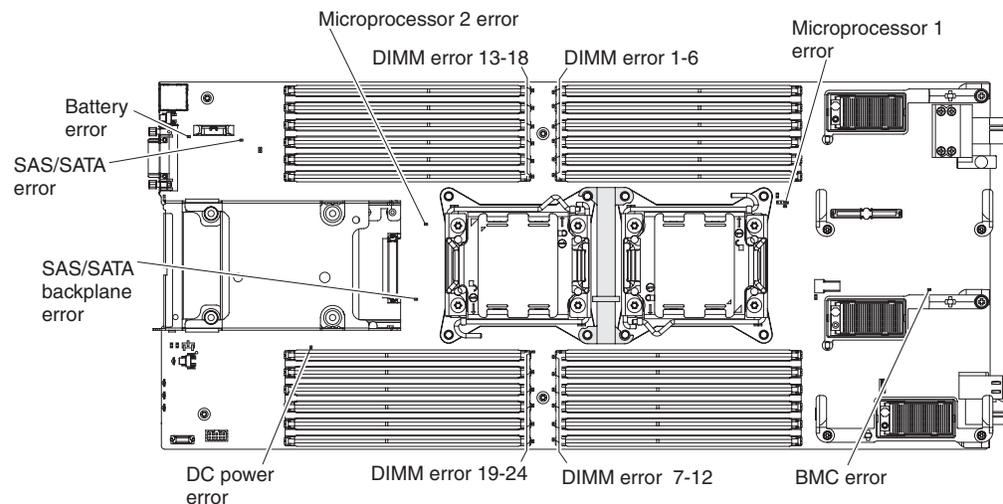
The following illustration shows the locations of the LEDs on the system board.

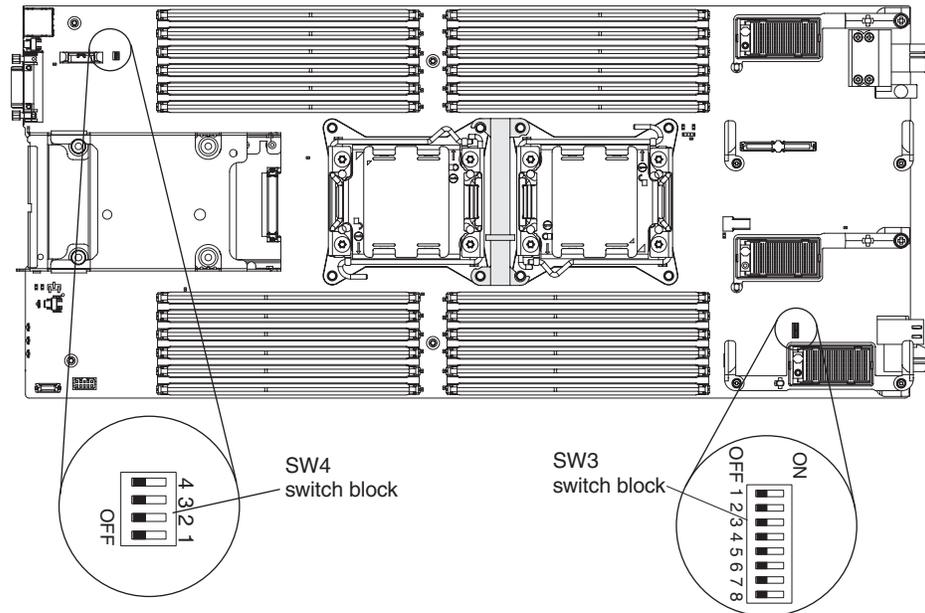
The following illustration shows the location of the switch block on the system board.

The following table describes the functions of the switches on switch blocks SW3 and SW4.

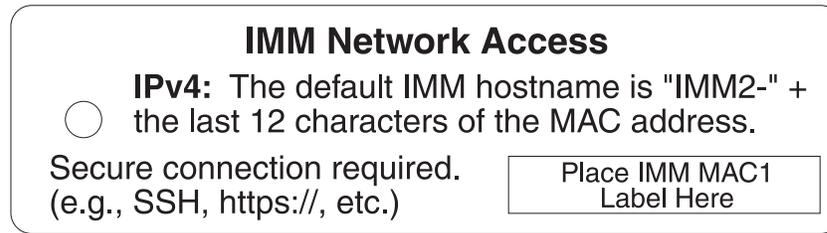
Front

To access the web interface, you need the IP address of the IMM2. You can locate the IP address by viewing the network access tag. The network access tag is attached to the front of the compute node. The front of the network access tag lists the first four IMM MAC addresses in the lower-right corner, as shown in the following illustration.

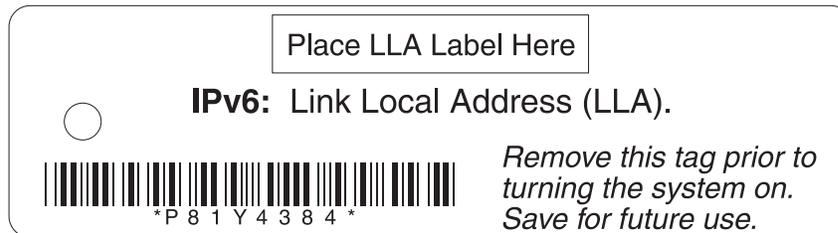
Rear

The rear of the network access tag lists the IPv6 link local address (LLA), as shown in the following illustration.

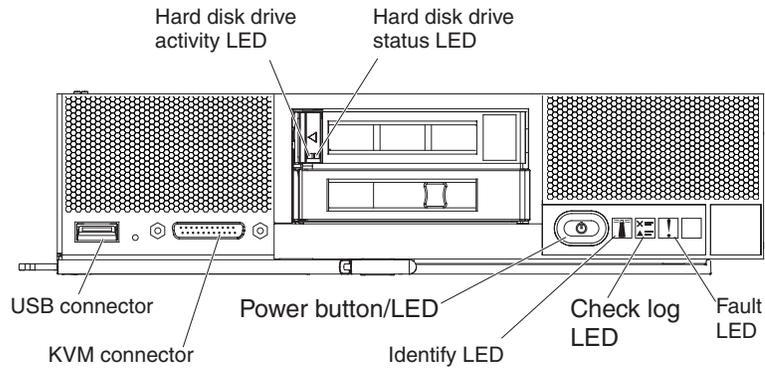
1. Look at the control panel on the front of the compute node.

- If the check log LED is lit, it indicates that a condition that causes an event to log in the IMM event log has occurred.
 - If the fault LED is lit, it indicates that an error has occurred; view the light path diagnostics panel and LEDs to isolate the failing component.

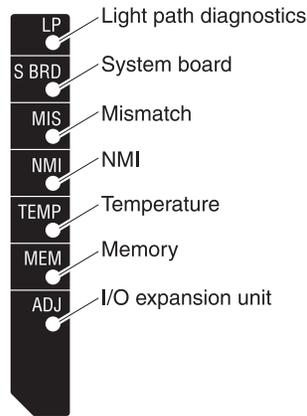
The following illustration shows the LEDs on the light path diagnostics panel.

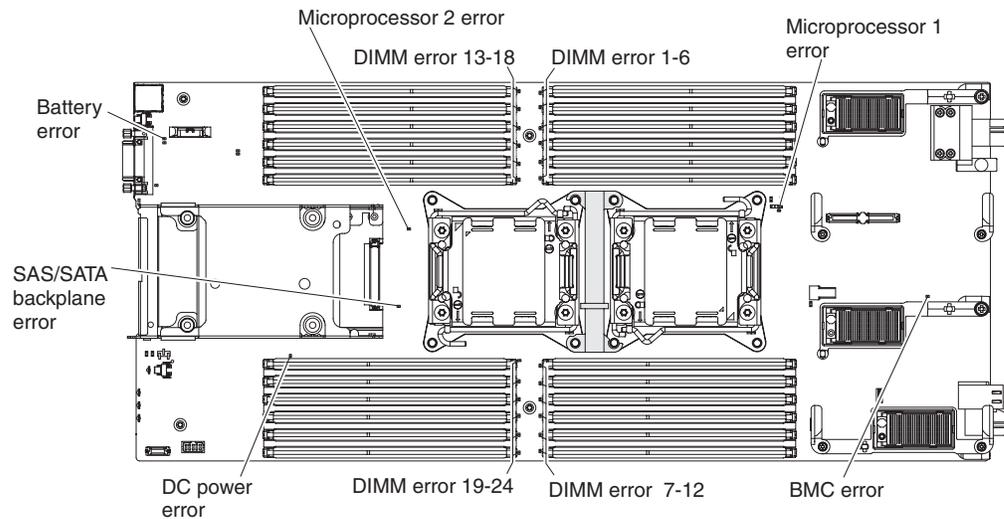
The following illustration shows the locations of the light path diagnostics LEDs on the system board.

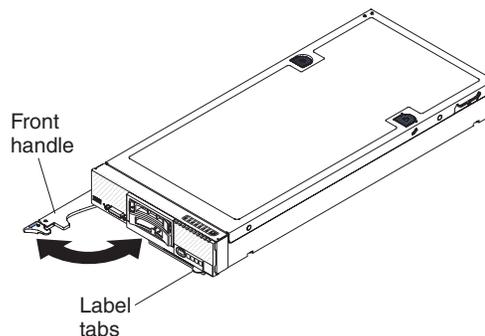
1. Open the front handle as shown in the illustration. The compute node moves out of the node bay approximately 0.6 cm (0.25 inch).

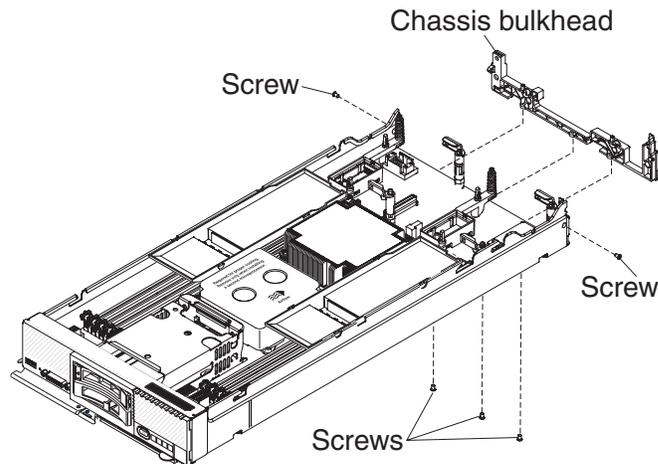
To remove the chassis bulkhead, complete the following steps.

1. Remove the cover (see “Removing the compute node cover” on page 399).
2. Remove the I/O expansion adapters (see “Removing an I/O expansion adapter” on page 427).
3. Remove the fabric connector (see “Removing a fabric connector” on page 420).
4. Carefully place the chassis on its side with the front handle side up.

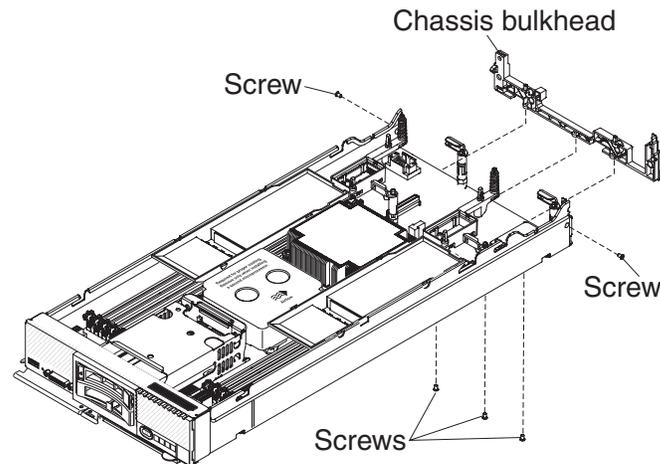
To install the chassis bulkhead, complete the following steps.

1. Remove the cover (see “Removing the compute node cover”).
2. Remove the fabric connector (see “Removing a fabric connector” on page 420).
3. Position the bulkhead in the chassis.
4. Using a T8 Torx screwdriver, install the screws that secure the bulkhead to the sides of the chassis.
5. Carefully place the chassis on its side with the front handle side up.
6. Using a T8 Torx screwdriver, install the screws that secure the bulkhead to the bottom of the chassis.
7. Carefully return the chassis to the bottom-side-down orientation.
8. Install the fabric connector (see “Installing a fabric connector” on page 421).
9. Install the I/O expansion adapters (see “Installing an I/O expansion adapter” on page 428).
10. Install the air baffles, if you removed them.

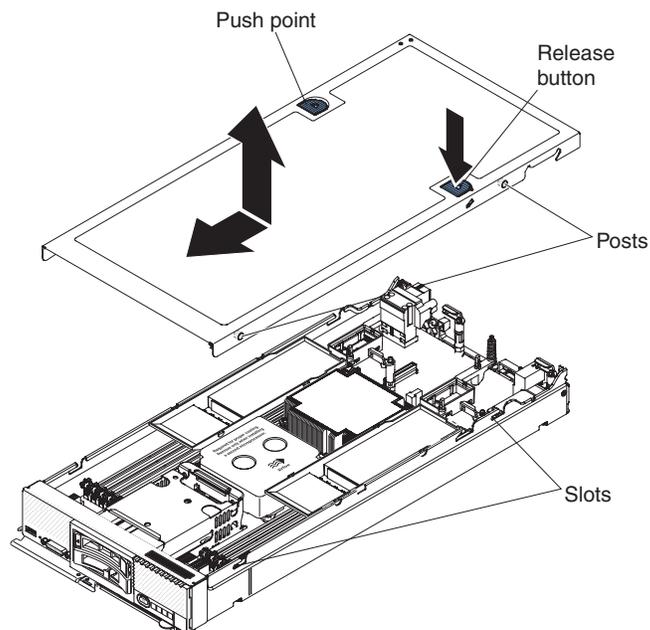
1. Press on the release button and the push point at the same time and slide the cover toward the rear of the compute node.
2. Lift the cover away from the compute node.

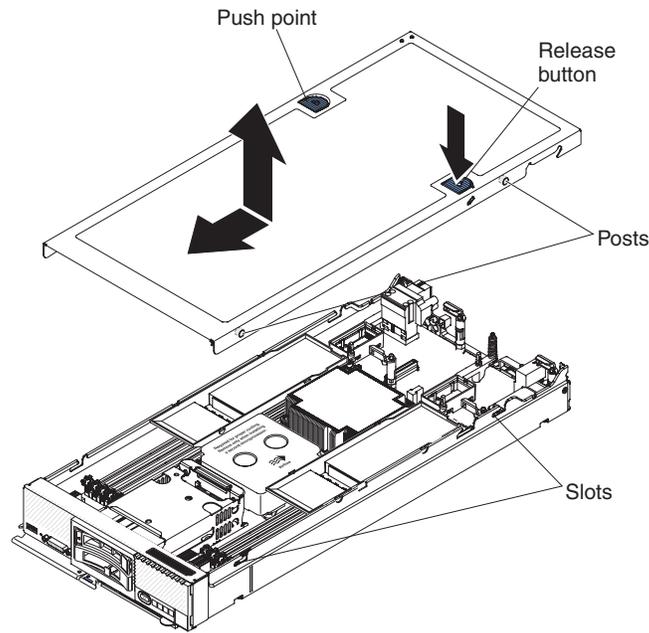
1. Carefully lay the compute node on a flat, static-protective surface, orienting the compute node with the bezel pointing toward you.
2. Orient the cover so that the posts on the inside of the cover slide into the slots on the compute node.

3. Hold the front of the compute node and slide the cover forward to the closed position, until it clicks into place.
4. To install a system service label, align the label on the cover, remove the backing, and press the label on the cover.

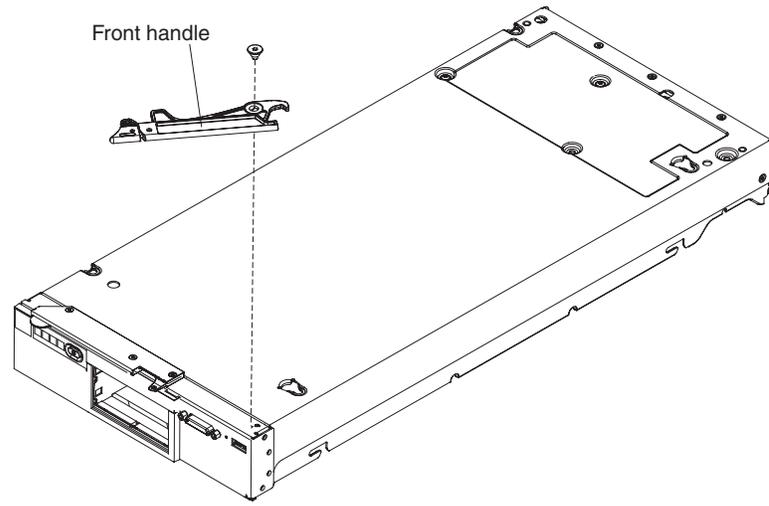
1. Locate the screw that attaches the handle to the compute node.
2. Using a T15 Torx screwdriver, remove the screw from the front handle and save the screw in a safe place. Use the same screw when you install a front handle.

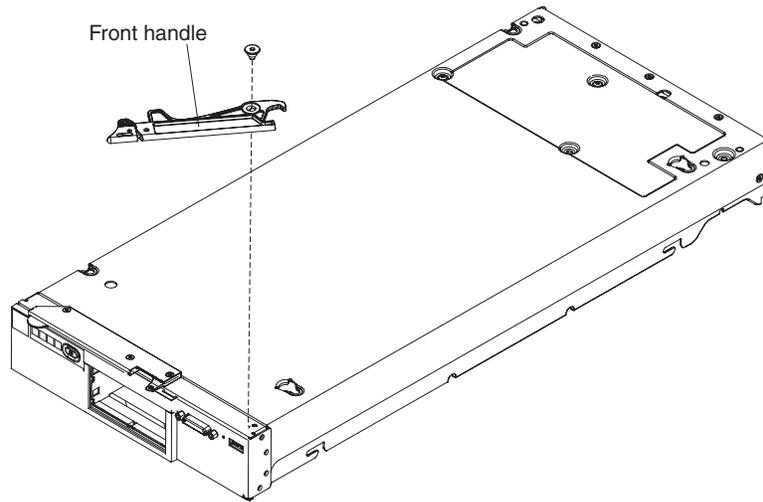
1. Orient the front handle so that the blue release latch is toward the middle of the compute node.
2. Align the hole in the handle with the hole on the compute node where the handle is installed.
3. Using a T15 Torx screwdriver, install the screw that secures the handle. Install the screw that you removed when you removed the handle.

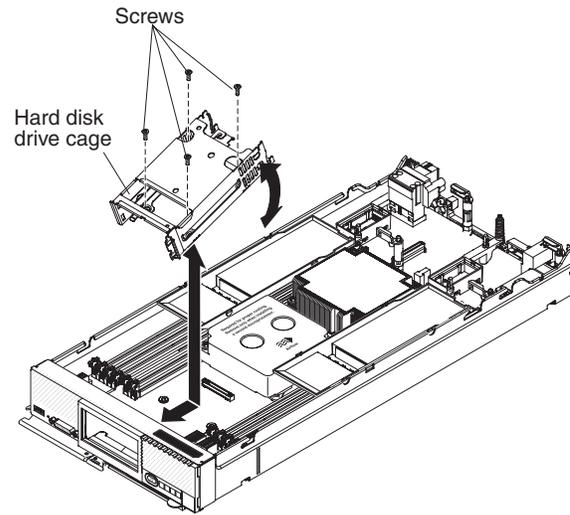
1. Remove the cover (see “Removing the compute node cover” on page 399).
2. Remove the hot-swap hard disk drives and hard disk drive bay fillers.
3. Remove the hard disk drive backplane (see “Removing the hard disk drive backplane” on page 421).
4. Using a T8 Torx screwdriver, remove the four screws from the cage and rotate the cage from under the bezel; then, remove the cage from the compute node at an angle.

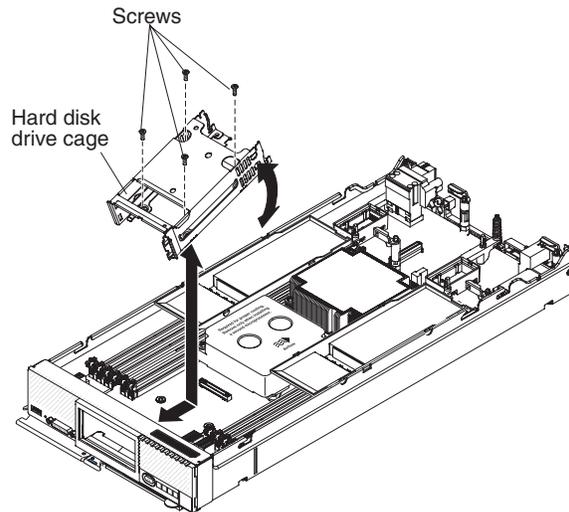
1. Remove the cover (see “Removing the compute node cover” on page 399).
2. Position the cage in the bezel at an angle and rotate the cage into position on the system board.
3. Align the cage with the screw holes on the system board.
4. Using a T8 Torx screwdriver, insert the four screws and secure the cage in the compute node.
5. Install the hard disk drive backplane (see “Installing the hard disk drive backplane” on page 422).
6. Insert the hot-swap hard disk drives and hard disk drive bay fillers.

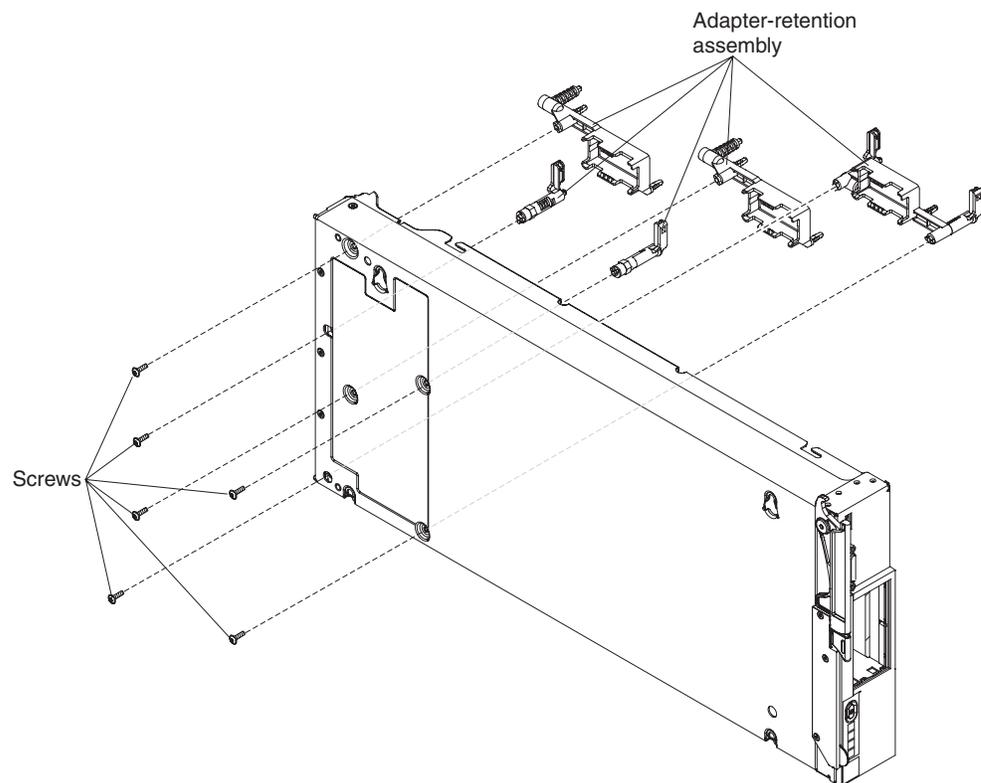
1. Remove the cover (see “Removing the compute node cover” on page 399).
2. Remove the air baffles.
3. If necessary, remove the I/O expansion adapters (see “Removing an I/O expansion adapter” on page 427).
4. Carefully place the chassis on its side with the front handle side up.
5. Using a T10 Torx screwdriver, remove the six screws that secure the adapter-retention assembly.
6. Lift the adapter-retention assembly from the system board.
7. Carefully return the chassis to the bottom-side-down orientation.

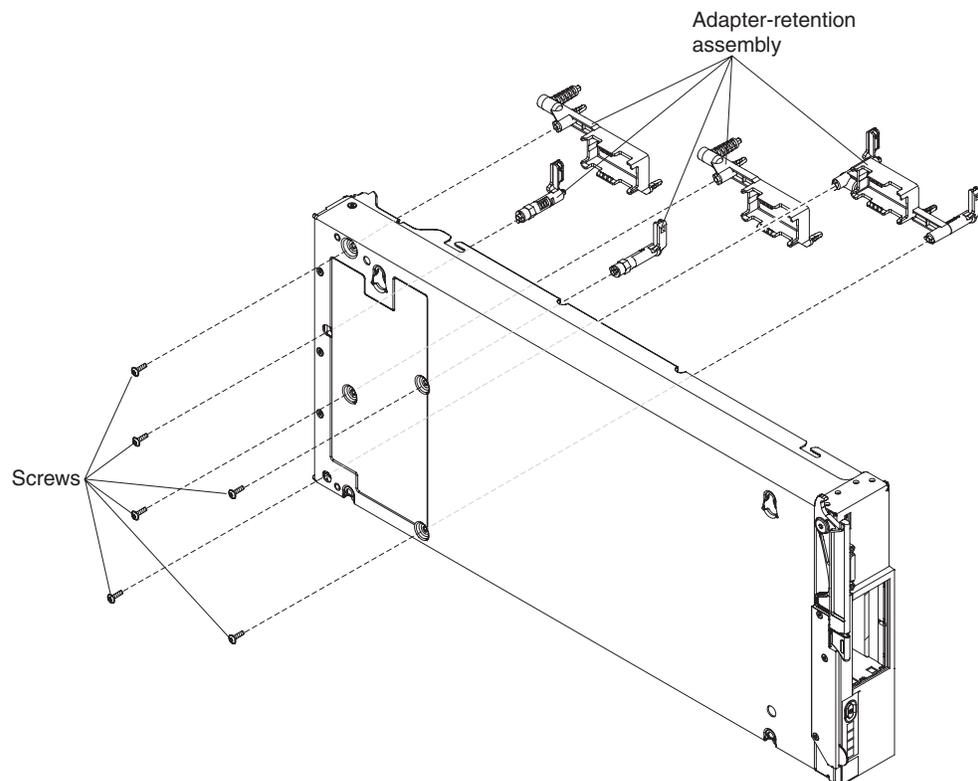
3. Carefully place the chassis on its side with the front handle side up.
4. Align the adapter-retention assembly on the system board.
5. Using a T10 Torx screwdriver, install the screws that secure the adapter-retention assembly.
6. Carefully return the chassis to the bottom-side-down orientation.
7. Install the I/O expansion adapters, if you removed them (see “Installing an I/O expansion adapter” on page 428).
8. Install the air baffles.

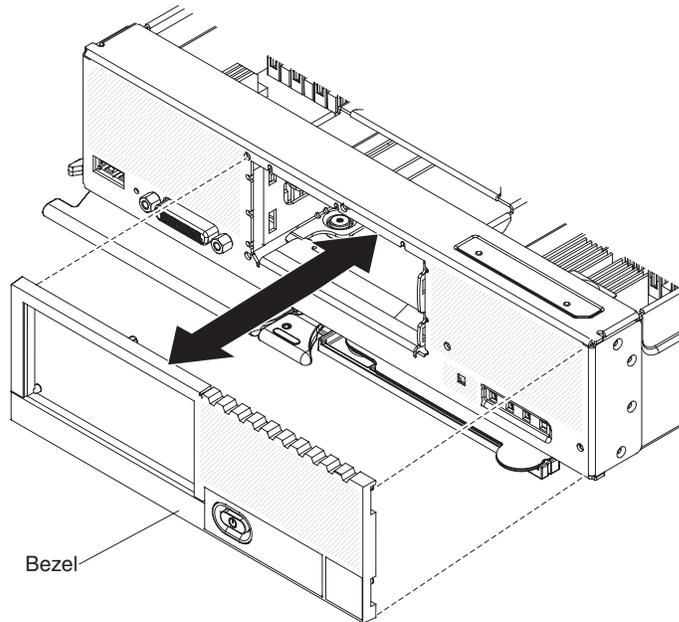
1. Use a flat-blade screwdriver to carefully pull the bezel from the compute node.
2. Lift the bezel from the compute node.

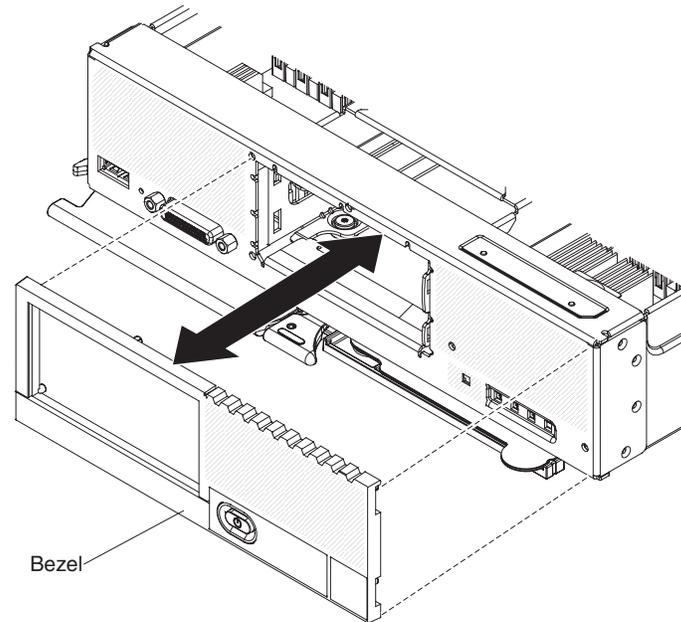
1. Position the bezel on the front of the compute node.
2. Press the bezel securely against the chassis.

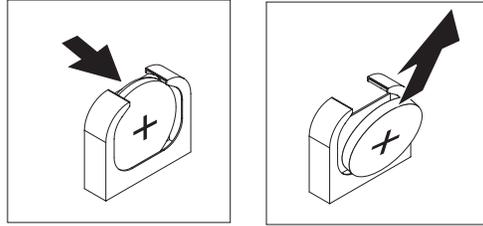
1. Remove the cover (see “Removing the compute node cover” on page 399).
2. Locate the CMOS battery on the system board (see “System-board connectors” on page 15).
3. If a cover is over the CMOS battery, remove the cover.
4. Pivot the CMOS battery toward the middle of the compute node.

5. Lift the CMOS battery from the socket.

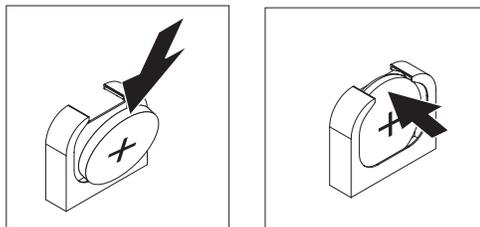
1. Remove the cover (see “Removing the compute node cover” on page 399).
2. Follow any special handling and installation instructions that come with the CMOS battery.
3. Locate the CMOS battery socket on the system board (see “System-board connectors” on page 15).
4. Orient the CMOS battery so that the positive (+) side faces in toward the center of the compute node.

5. Pivot the CMOS battery so that you can insert it into the bottom of the socket.
6. As you slide the CMOS battery into place, press the top of the CMOS battery into the socket.
7. If you removed a cover from the battery, replace the cover.

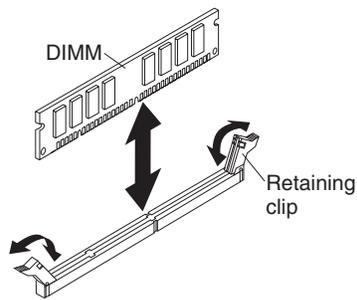
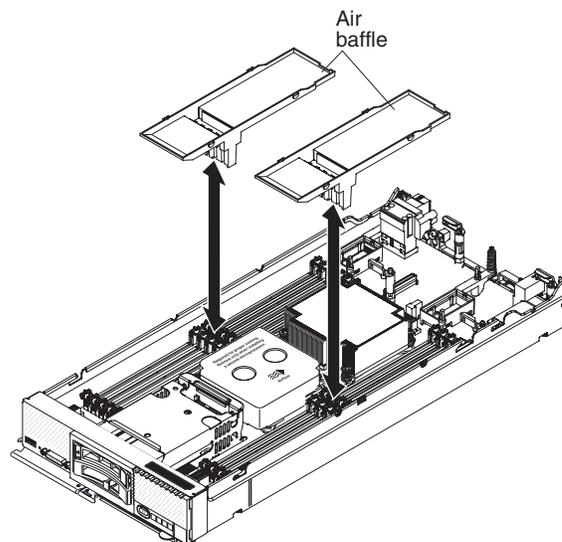
1. Remove the cover (see “Removing the compute node cover” on page 399).
2. Remove the air baffle installed over the DIMM connector.

3. Locate the DIMM connectors (see “System-board connectors” on page 15). Determine which DIMM you want to remove from the compute node.

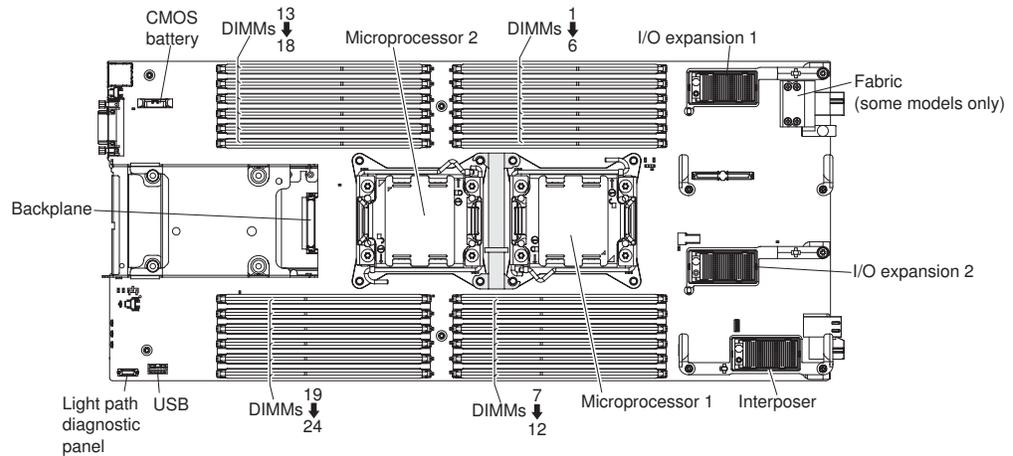
The following illustration shows the system-board components, including the DIMM connectors.

The memory is accessed internally through eight channels (four channels for each microprocessor). Each channel contains three DIMM connectors. Each channel can have a maximum of eight ranks. The following table lists each channel and shows which DIMM connectors are in the channel.

The compute node has a total of 24 dual inline memory module (DIMM) connectors. The compute node supports low-profile (LP) DDR3 DIMMs with error-correcting code (ECC) in 2 GB, 4 GB, 8 GB, 16 GB, and 32 GB capacities.

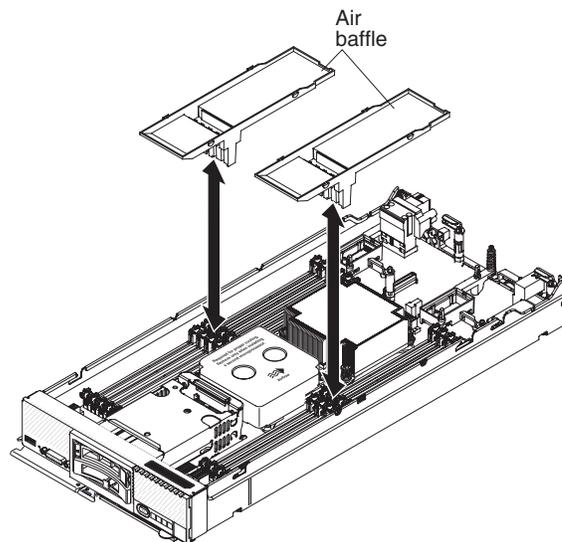
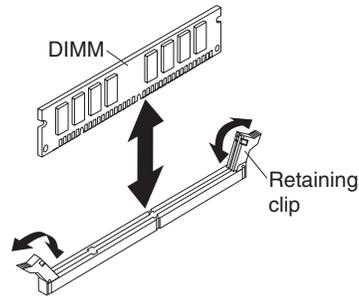
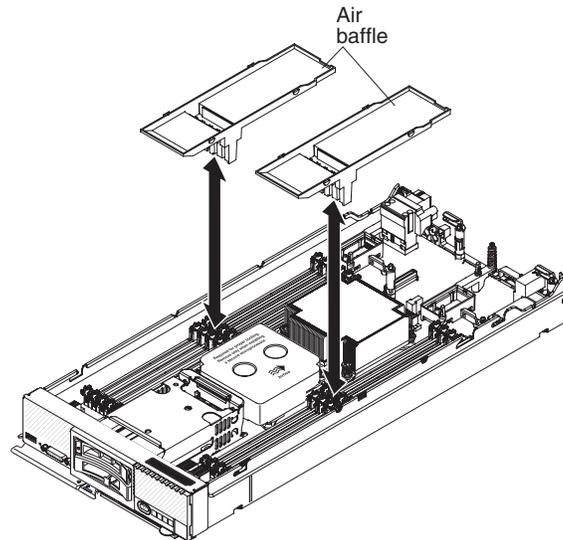
4. Locate the DIMM connectors (see “System-board connectors” on page 15). Determine in which DIMM connector you want to install the DIMM.
5. Touch the static-protective package that contains the DIMM to any *unpainted* metal surface on the IBM Flex System chassis or any *unpainted* metal surface on any other grounded rack component in the rack in which you are installing the DIMM for at least 2 seconds; then, remove the DIMM from its package.

6. Make sure that both retaining clips on the DIMM connector are in the open position.
7. Turn the DIMM so that the DIMM keys align correctly with the DIMM connector on the system board.
Attention: To avoid breaking the retaining clips or damaging the DIMM connector, handle the clips gently.
8. Press the DIMM into the DIMM connector. The retaining clips lock the DIMM into the connector.
9. Make sure that the small tabs on the retaining clips engage the notches on the DIMM. If there is a gap between the DIMM and the retaining clips, the DIMM has not been correctly installed. Press the DIMM firmly into the connector, and then press the retaining clips toward the DIMM until the tabs are fully seated. When the DIMM is correctly installed, the retaining clips are parallel to the sides of the DIMM.

10. Install the air baffle over the DIMM connector.
Attention: To maintain proper system cooling, do not operate the compute node without air baffles installed over the DIMM connectors.

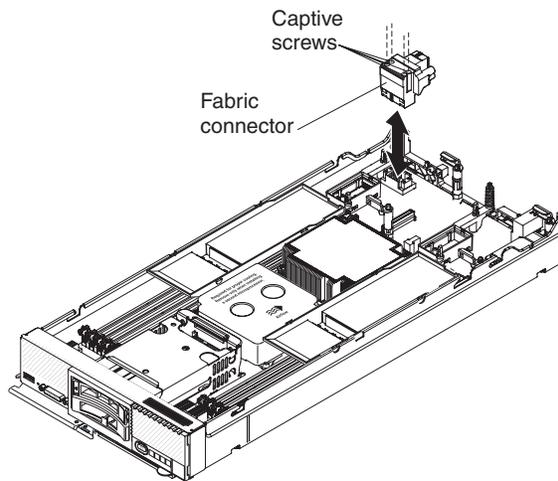
1. Remove the cover (see “Removing the compute node cover” on page 399).
2. Locate the fabric connector on the system board (see “System-board layouts” on page 15).
3. Using a Phillips screwdriver, loosen the four captive screws that secure the fabric connector.
4. Lift the fabric connector from the system board and store it in a safe place.

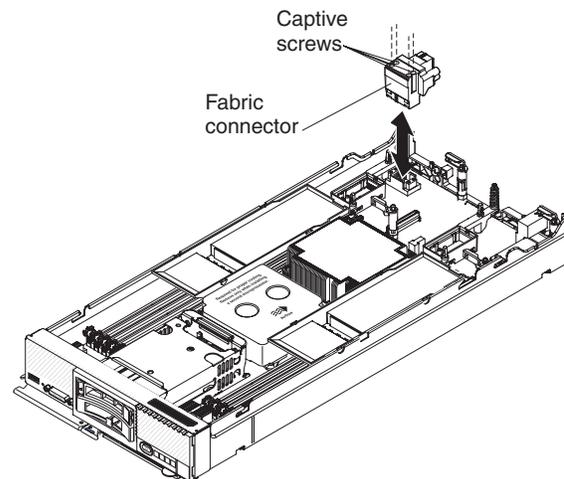
1. Remove the cover (see “Removing the compute node cover” on page 399).
2. Locate the fabric connector (see “System-board layouts” on page 15).
3. Orient the fabric connector on the system board.
4. Using a Phillips screwdriver, tighten the four captive screws to secure the fabric connector.

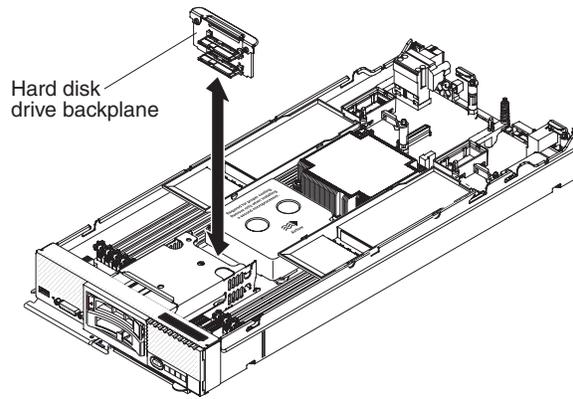
1. Remove the cover (see “Removing the compute node cover” on page 399).
2. Pull the hard disk drives out slightly from the bays to disengage them from the backplane and remove any hard disk drive bay fillers.
3. Lift out the hard disk drive backplane.

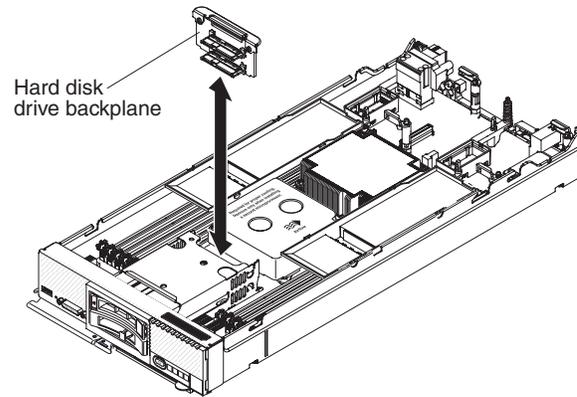
1. Remove the cover (see “Removing the compute node cover” on page 399).
2. Align the backplane with the hard disk drive cage and the connector on the system board and press the backplane into position until it is fully seated in the connector.
3. Insert the hot-swap hard disk drives and hard disk drive bay fillers.

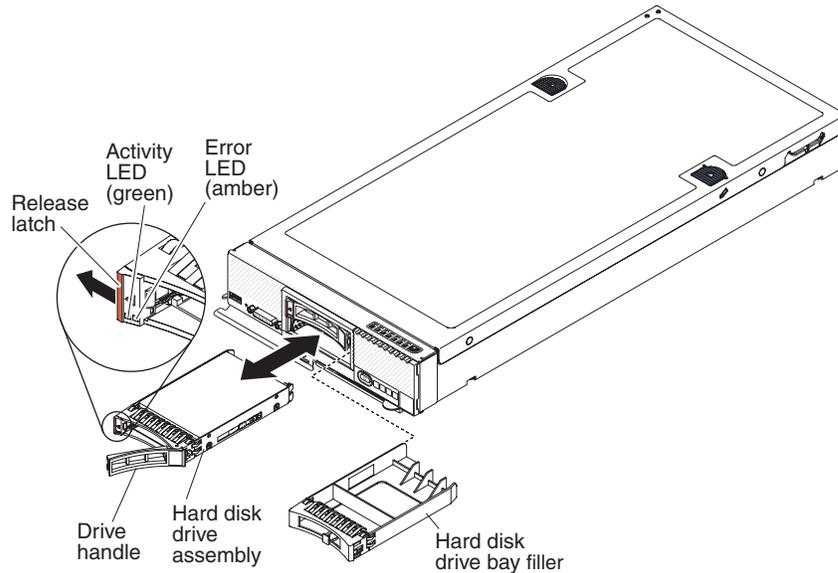
1. Press the release latch (orange) on the hard disk drive to release the drive handle.
2. Pull the release handle to remove the drive from the bay.

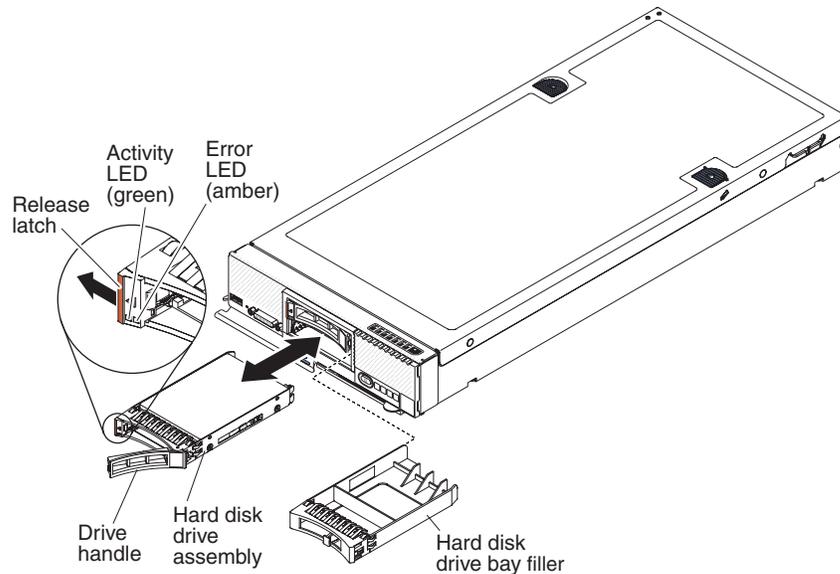
1. Identify the hard disk drive bay in which you plan to install the hot-swap hard disk drive.
2. If a hard disk drive bay filler is installed, remove it from the compute node by pulling the release lever and sliding the filler away from the compute node.
3. Touch the static-protective package that contains the hot-swap hard disk drive to any *unpainted* metal surface on the IBM Flex System chassis or any *unpainted* metal surface on any other grounded rack component; then, remove the hard disk drive from the package.
4. Open the release lever on the hot-swap hard disk drive and slide the drive into the bay until it is firmly seated in the connector.
5. Lock the hot-swap hard disk drive into place by closing the release lever.
6. Check the hard disk drive status LEDs to make sure that the hard disk drive is operating correctly.

The compute node has two SAS or SATA hard disk drive bays for installing hot-swap hard disk drives, such as hot-swap SAS hard disk drives. One hard disk drive might already be installed in the compute node. If the compute node is equipped with one hard disk drive, you can install an additional drive. The compute node supports using RAID 0 or RAID 1 when two hard disk drives of the same interface type are installed. See “Configuring a RAID array” on page 32 for information about RAID configuration.

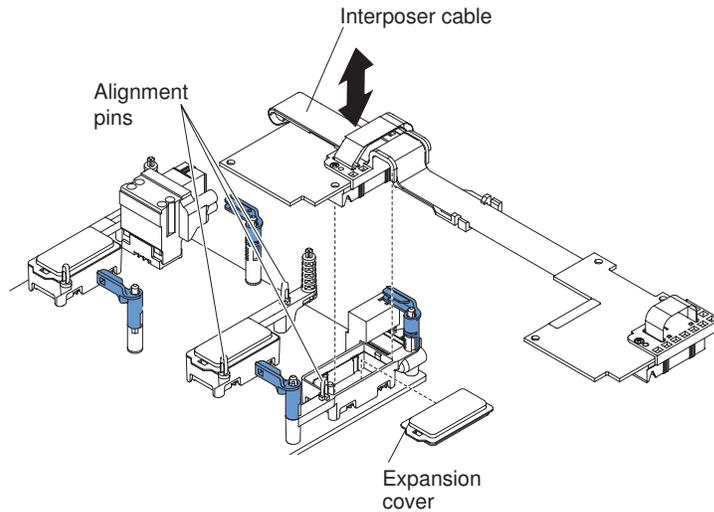
1. Remove the cover (see “Removing the compute node cover” on page 399).
2. Locate the interposer connector (see “System-board connectors” on page 15).
3. If an I/O expansion card is installed over the interposer connector, remove it (see “Removing an I/O expansion adapter” on page 427).
4. Lift the interposer cable from the connector and remove the cable from the compute node. You might find it helpful to rock the cable back and forth to disengage the cable.
5. If necessary, install the I/O expansion card (see “Installing an I/O expansion adapter” on page 428).

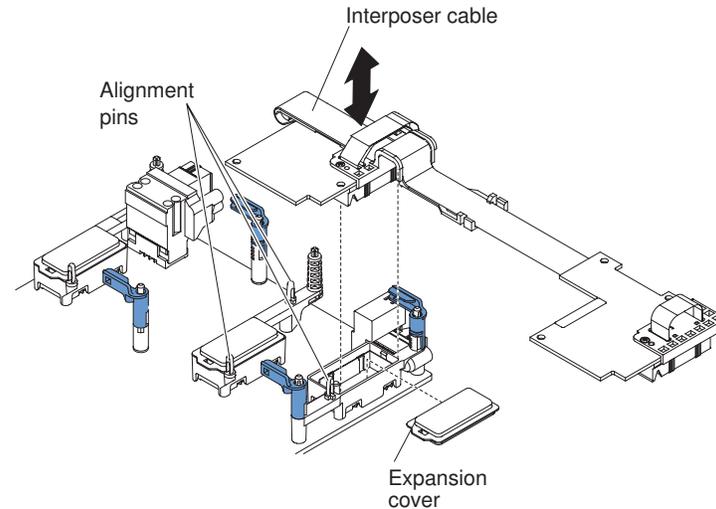
1. Remove the cover (see “Removing the compute node cover” on page 399).
2. Locate the interposer connector (see “System-board connectors” on page 15).
3. If an I/O expansion adapter is installed over the interposer connector, remove it (see “Removing an I/O expansion adapter”).

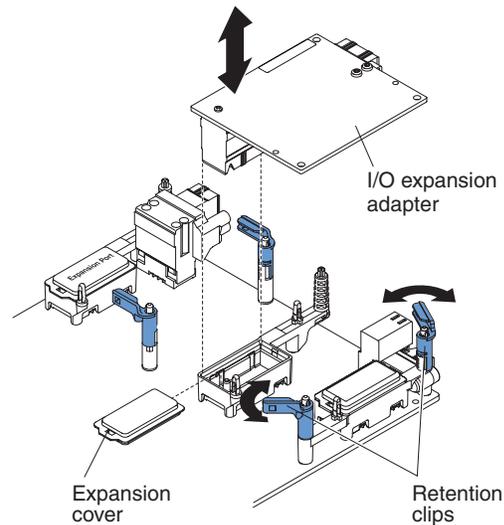
1. Remove the cover (see “Removing the compute node cover” on page 399).
2. Locate the I/O expansion adapter connectors (see “System-board layouts” on page 15).
3. Open the retention clips.
4. Lift the I/O expansion adapter from the connector and remove the I/O expansion adapter from the compute node. You might find it helpful to rock the adapter back and forth to disengage the adapter.

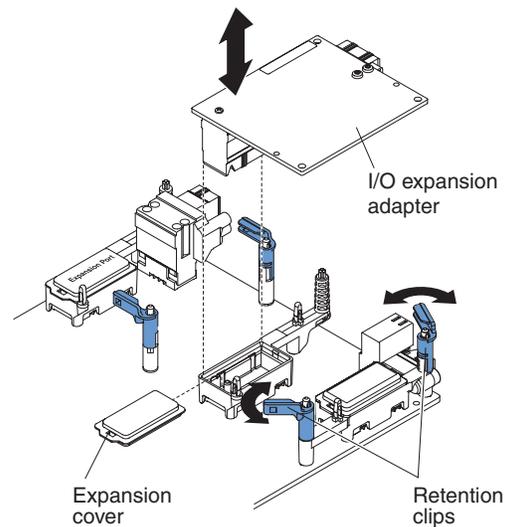
1. Remove the cover (see "Removing the compute node cover" on page 399).
2. Locate the I/O expansion connectors (see "System-board connectors" on page 15).
3. Remove the expansion cover from the connector, if one is present.
4. Touch the static-protective package that contains the expansion adapter to any *unpainted* metal surface on the IBM Flex System chassis or any *unpainted* metal surface on any other grounded rack component; then, remove the expansion adapter from the package.
5. Open the retention clips.
6. Orient the connector on the expansion adapter with the I/O expansion connector and alignment pins on the system board; then, press the adapter into the I/O expansion connector.
7. Firmly press on the indicated locations to seat the expansion adapter in the connector and over the alignment pins.
8. Close the retention clips.

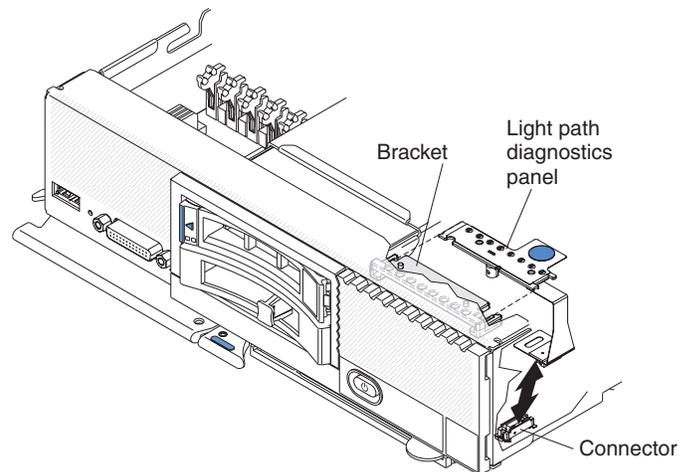
1. Remove the cover (see “Removing the compute node cover” on page 399).
2. Pull the light path diagnostics panel out of the bracket.
3. Disconnect the cable from the system board.
4. Lift the light path diagnostics panel from the compute node.

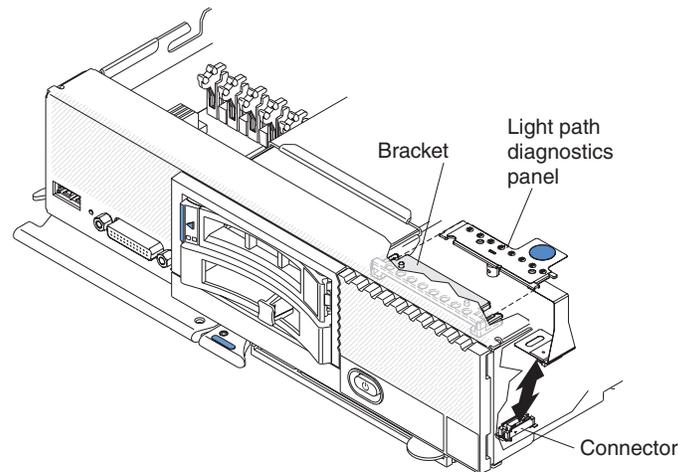
1. Remove the cover (see “Removing the compute node cover” on page 399).
2. Connect the cable on the system board.
3. Align the light path diagnostics panel with the bracket.
4. Press the light path diagnostics panel securely in the bracket.

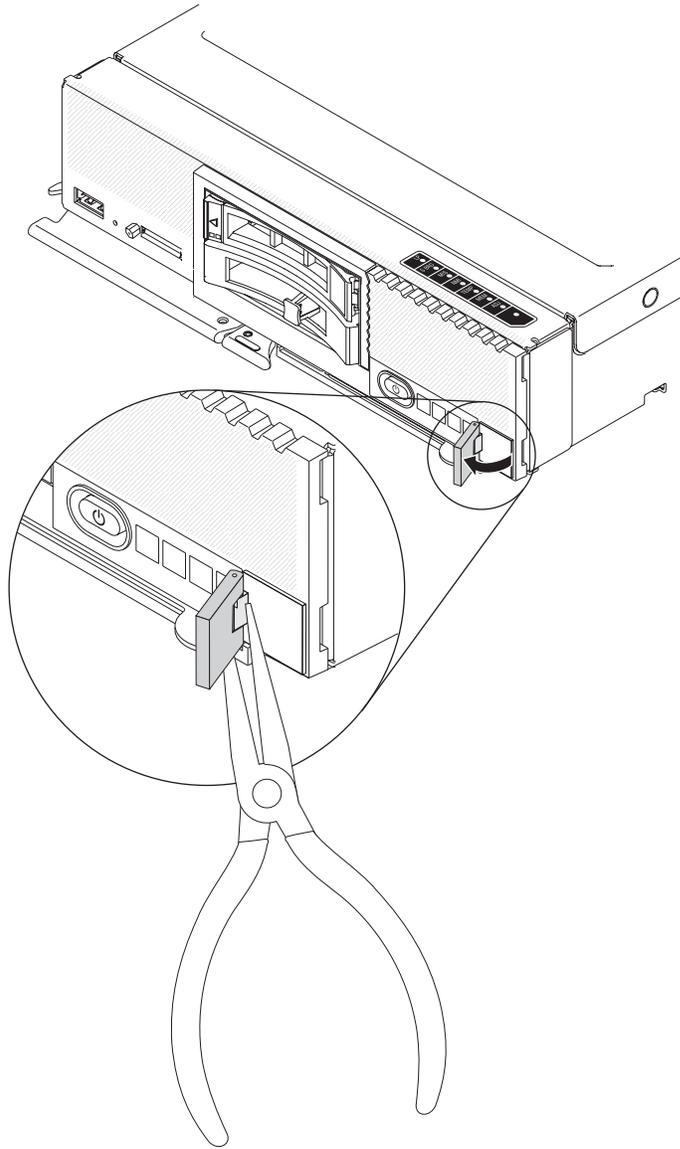
1. If the RFID tag is attached to the hinge, open the RFID tag.
2. Use pliers to carefully grip the hinge and gently pull and twist the base from the bezel.

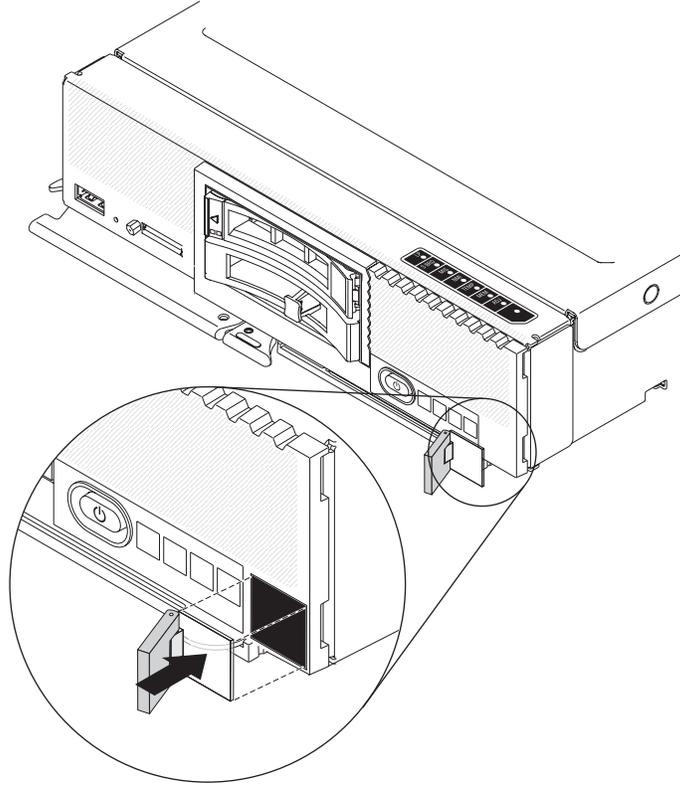
1. Make sure that the surface you are installing the tag on is thoroughly clean and dry.
2. Remove the backing from the base to expose the adhesive.
3. Position the RFID tag over the ID label on the front of the bezel.
4. Press the RFID tag securely against the bezel and hold firmly in place for 30 seconds.

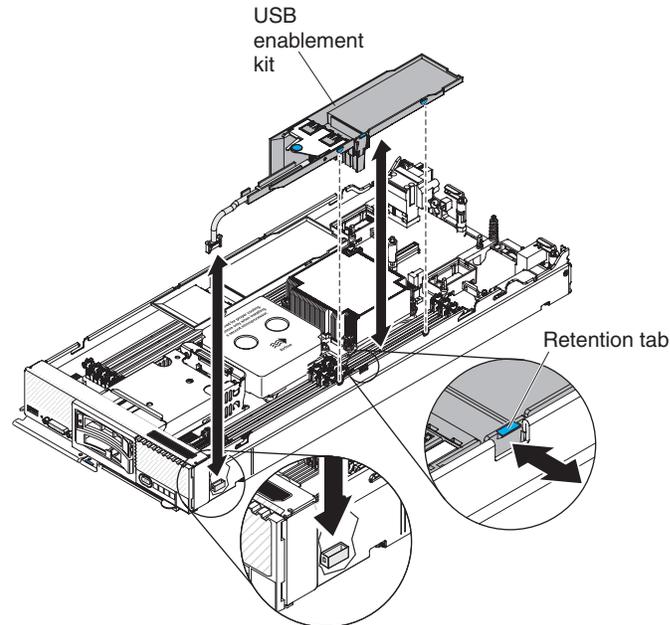
1. Remove the cover (see “Removing the compute node cover” on page 399).
2. Remove any USB flash drives that are installed in the USB connectors (see “Removing the USB flash drive” on page 435).
3. Disconnect the USB cable from the system board.
4. Release the retention tab from the side of the chassis and remove the USB enablement kit from the compute node.
5. Install an air baffle over the DIMM connectors.

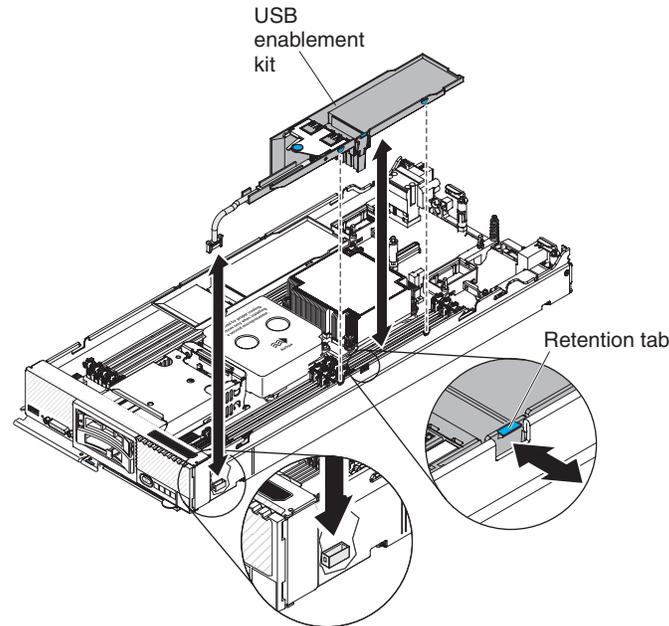
1. Remove the cover (see “Removing the compute node cover” on page 399).
2. Remove the air baffle next to the USB connector.
3. Install the USB enablement kit over the DIMM connectors.
4. Press the retention tab into the matching notch in the chassis to secure the kit.
5. Locate the USB connector on the system board (see “System-board connectors” on page 15).
6. Connect the USB cable to the USB connector on the system board.
7. Install any USB flash drives in the connectors (see “Installing the USB flash drive” on page 436).
