IBM Flex System x240 Compute Node
Types 7863, 8737, and 8738
Installation and Service Guide

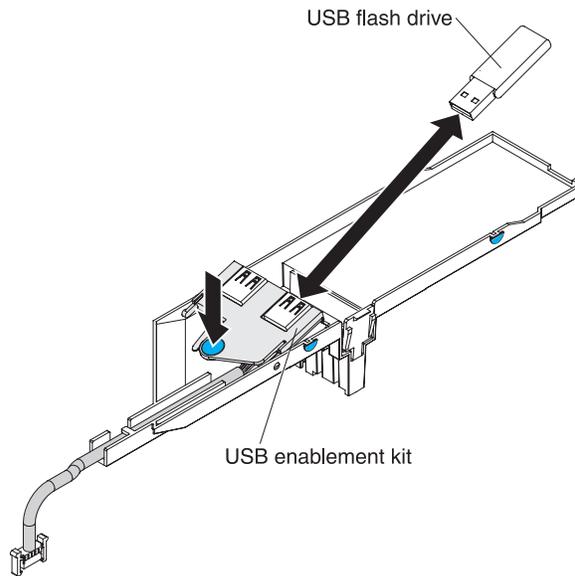
1. Remove the cover (see “Removing the compute node cover” on page 399).
2. Press the USB enablement kit to access the USB flash drive connectors.
3. Pull the USB flash drive out of the connector.

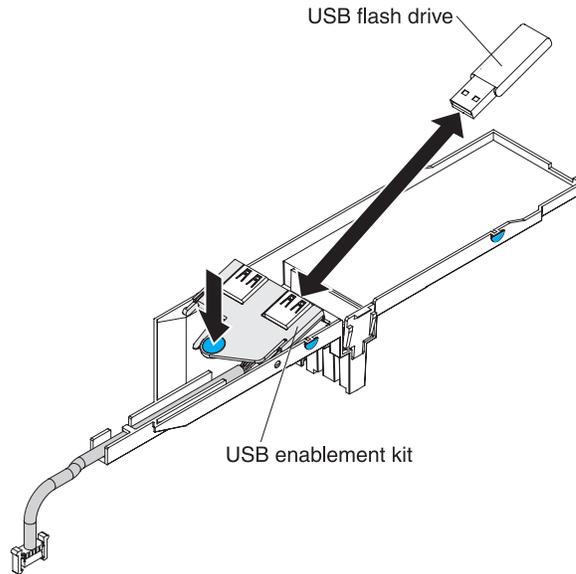
1. Remove the cover (see “Removing the compute node cover” on page 399).
2. Press on the USB enablement kit to access the USB flash drive connectors.
3. Push the USB flash drive into the connector.

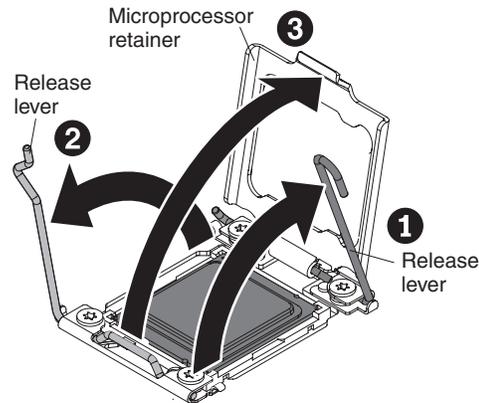
4. Open the microprocessor socket release levers and retainer.

- a. Identify which release lever is labeled as the first release lever to open, and open it.
- b. Open the second release lever on the microprocessor socket.
- c. Open the microprocessor retainer.

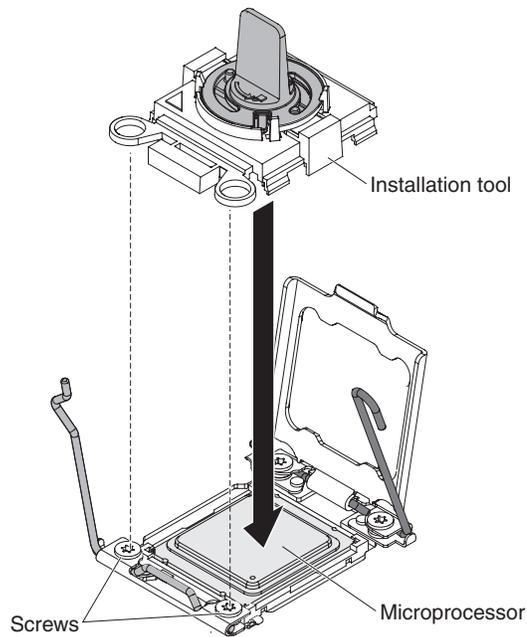
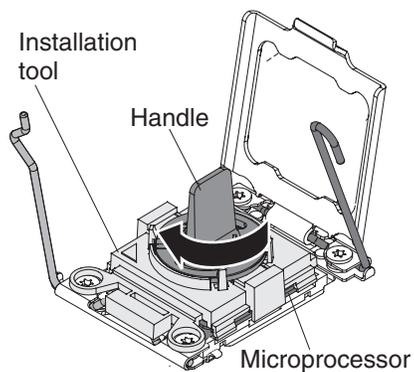
- b. Align the installation tool with the screws on the microprocessor socket, and lower the tool on the microprocessor. The installation tool rests flush on the socket only if it is aligned correctly.

- c. Twist the handle on the installation tool clockwise and lift the microprocessor out of the socket.

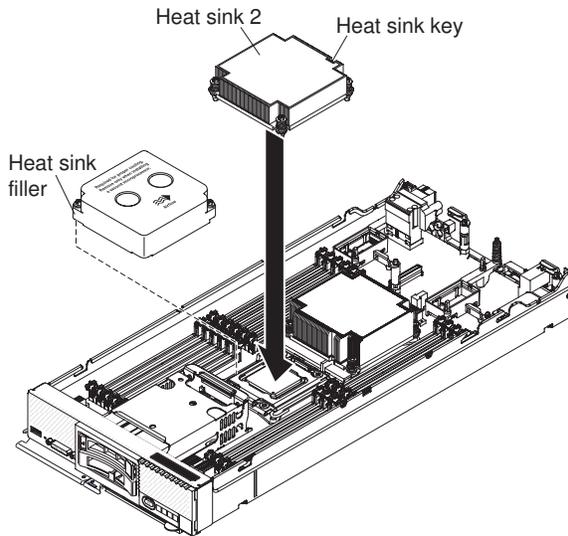
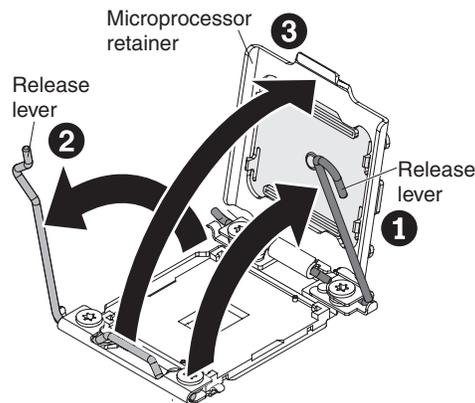
1. Remove the cover (see “Removing the compute node cover” on page 399).
2. If you are not installing a new microprocessor and a new heat sink, remove the thermal grease from the heat sink and microprocessor; then, apply new thermal grease before installation (see “Thermal grease” on page 445).
3. Remove the heat-sink filler, if one is present.
4. Open the microprocessor socket release levers and retainer.

- a. Identify which release lever is labeled as the first release lever to open and open it.
 - b. Open the second release lever on the microprocessor socket.
 - c. Open the microprocessor retainer.
5. Install the microprocessor on the microprocessor socket:

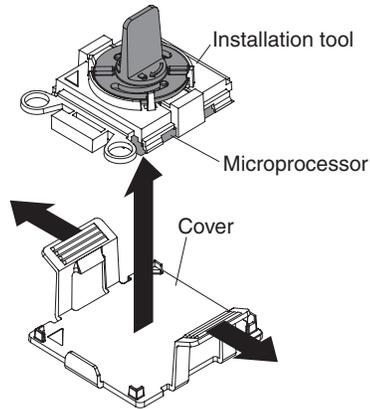
- a. Touch the static-protective bag that contains the new microprocessor to any *unpainted* surface on the IBM Flex System chassis or any *unpainted* metal surface on any other grounded rack component; then, carefully remove the microprocessor and installation tool from the package.
- b. Release the sides of the cover and remove the cover from the installation tool. The microprocessor is preinstalled on the installation tool.

Note: Do not touch the microprocessor contacts. Contaminants on the microprocessor contacts, such as oil from your skin, can cause connection failures between the contacts and the socket.

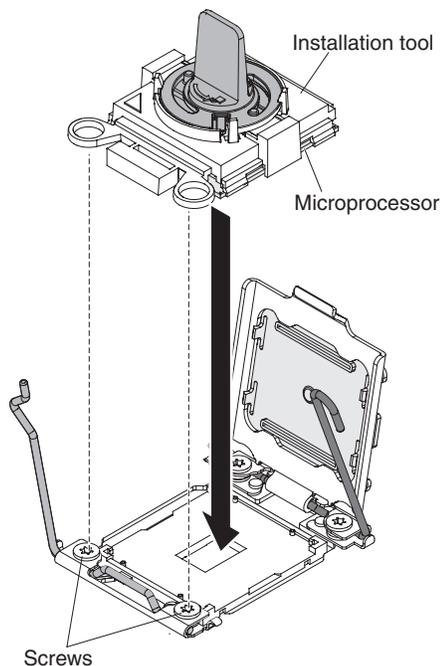
- c. Align the installation tool with the microprocessor socket. The installation tool rests flush on the socket only if it is properly aligned.

- d. Twist the handle on the microprocessor tool counterclockwise to insert the microprocessor into the socket. The microprocessor is keyed to ensure that the microprocessor is installed correctly. The microprocessor rests flush on the socket only if it is properly installed.

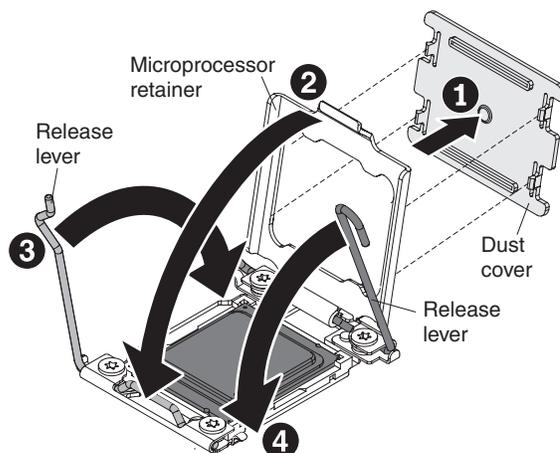
6. Close the microprocessor socket release retainer and levers.

- a. If a socket dust cover is installed over the microprocessor retainer, remove the dust cover from the compute node and store it in a safe place.
- b. Close the microprocessor retainer on the microprocessor socket.
- c. Identify which release lever is labeled as the first release lever to close, and close it.
- d. Close the second release lever on the microprocessor socket.

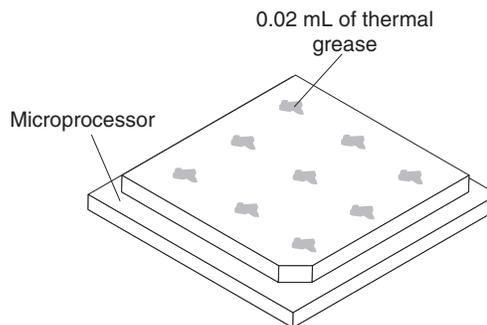
4. Use a clean area of the cleaning pad to wipe the thermal grease from the microprocessor; then, dispose of the cleaning pad after all of the thermal grease is removed.

5. Use the thermal-grease syringe to place nine uniformly spaced dots of 0.02 mL each on the top of the microprocessor.

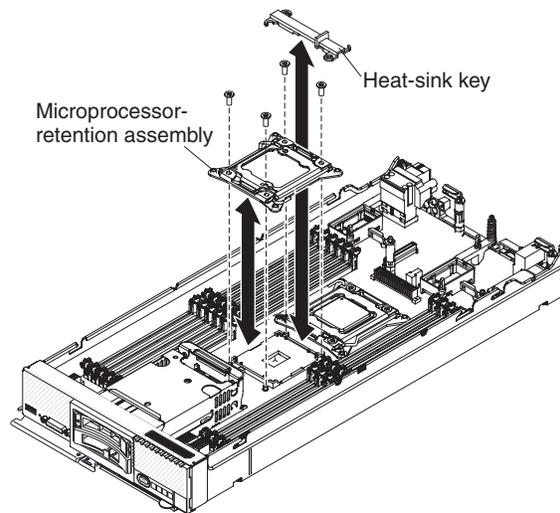
To remove a microprocessor-retention assembly, complete the following steps.

1. Remove the cover (see “Removing the compute node cover” on page 399).
2. Locate the microprocessor connector on the system board (see “System-board layouts” on page 15).
3. If a microprocessor and heat sink are installed, remove them (see “Removing a microprocessor and heat sink” on page 437).
4. Remove the heat-sink key from the microprocessor-retention assemblies and store it in a safe place.
5. Make sure that the microprocessor socket release levers are in the open position.
6. Using a T20 Torx screwdriver, remove the four screws that secure the microprocessor-retention assembly.

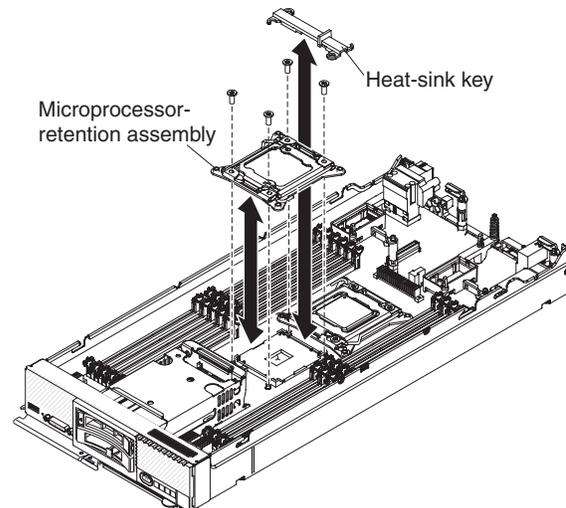
To install a microprocessor-retention assembly, complete the following steps.

1. Remove the cover (see “Removing the compute node cover” on page 399).
2. Make sure that the microprocessor socket release levers are in the open position.
3. Align the microprocessor-retention assembly on the system board.

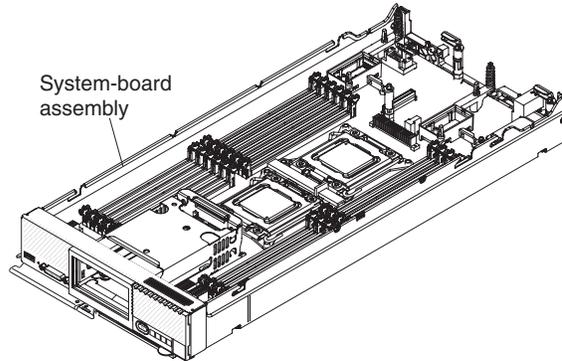
To remove the system-board assembly, complete the following steps:

1. Remove the cover (see “Removing the compute node cover” on page 399).
2. Remove all of the installed components in the following list from the system-board assembly; then, place them on a static-protective surface or install them on the new system-board assembly.

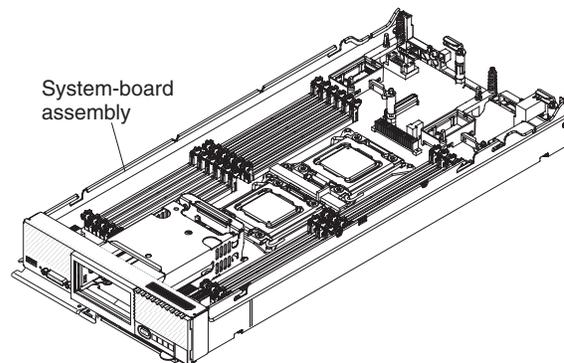
To install the system-board assembly, complete the following steps:

1. Install all of the components in the following list that you removed from the old system-board assembly onto the new system-board assembly.
 - DIMMs and air baffles (see “Installing a DIMM” on page 415).
 - Fabric connector (some models only) (see “Installing a fabric connector” on page 421).
 - USB enablement kit (see “Installing the USB enablement kit” on page 434).
 - I/O expansion adapters (see “Installing an I/O expansion adapter” on page 428).
 - Hard disk drives and hard disk drive fillers (see “Installing a hot-swap hard disk drive” on page 424).
 - Microprocessors, heat sinks, and microprocessor heat sink fillers. Use the microprocessor installation tool that comes with the CRU kit to remove each microprocessor from the system-board assembly and install each one
