Cisco Nexus 7000 Series NX-OS Software Upgrade and Downgrade Guide, Release 8.x

Cisco Nexus 7000 Series NX-OS Software Upgrade and Downgrade Guide

This document describes how to upgrade or downgrade the Cisco NX-OS software.

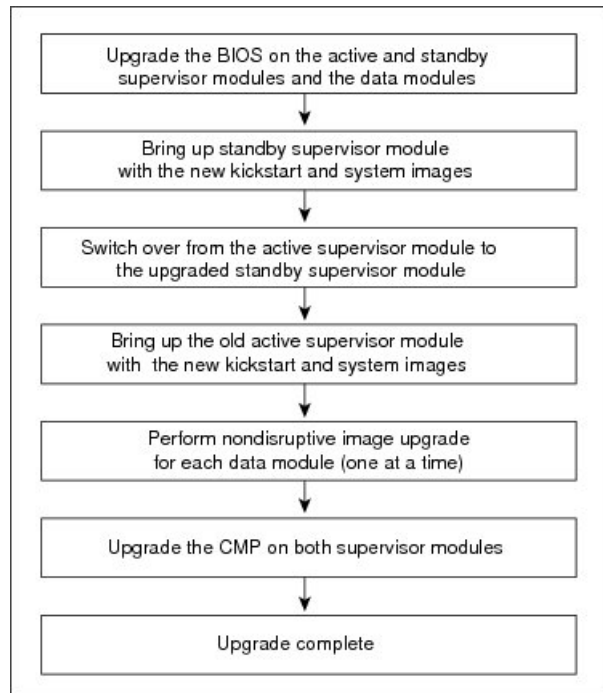
Figure 1: ISSU Process

The Cisco NX-OS software supports in-service software upgrades (ISSUs) on devices with dual supervisor modules. An ISSU can update the software images on your device without disrupting data traffic. Only control traffic is disrupted. If an ISSU will cause a disruption of data traffic, the Cisco NX-OS software warns you before proceeding so that you can stop the upgrade and reschedule it to a time that minimizes the impact on your network.

This figure shows the ISSU process.
