**Dell Technologies**

ME52XX Series Owner's Manual

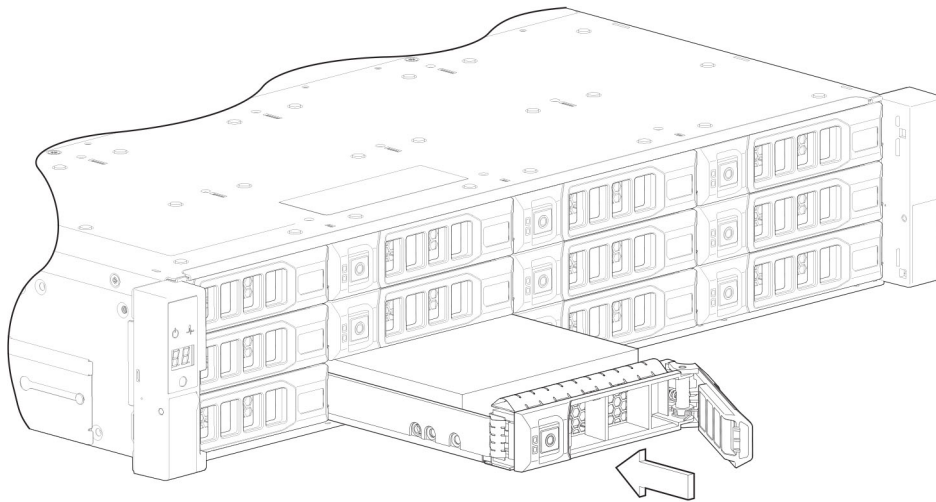
**Figure 44. Installing an LFF drive carrier module (1 of 2)**

2. Insert the drive carrier module into the enclosure.
3. Gently slide the drive carrier module into the enclosure until it stops moving.
