## TEST REPORT

Report No.: HC60165/2014

Product Description: Outdoor Hemispheric Dome (Smoke Dome Cover)  
Style/ Item No.: I71/ No.1  
Manufacturer/ Vendor: ACTi Corporation  
Country of Origin: Taiwan  
Quantity: Total 1 piece  
Testing Period: Jun. 30, 2014  
Note: (Client's declaration) The I72 and I73 used the identical enclosure.

## 1. Impact Test:

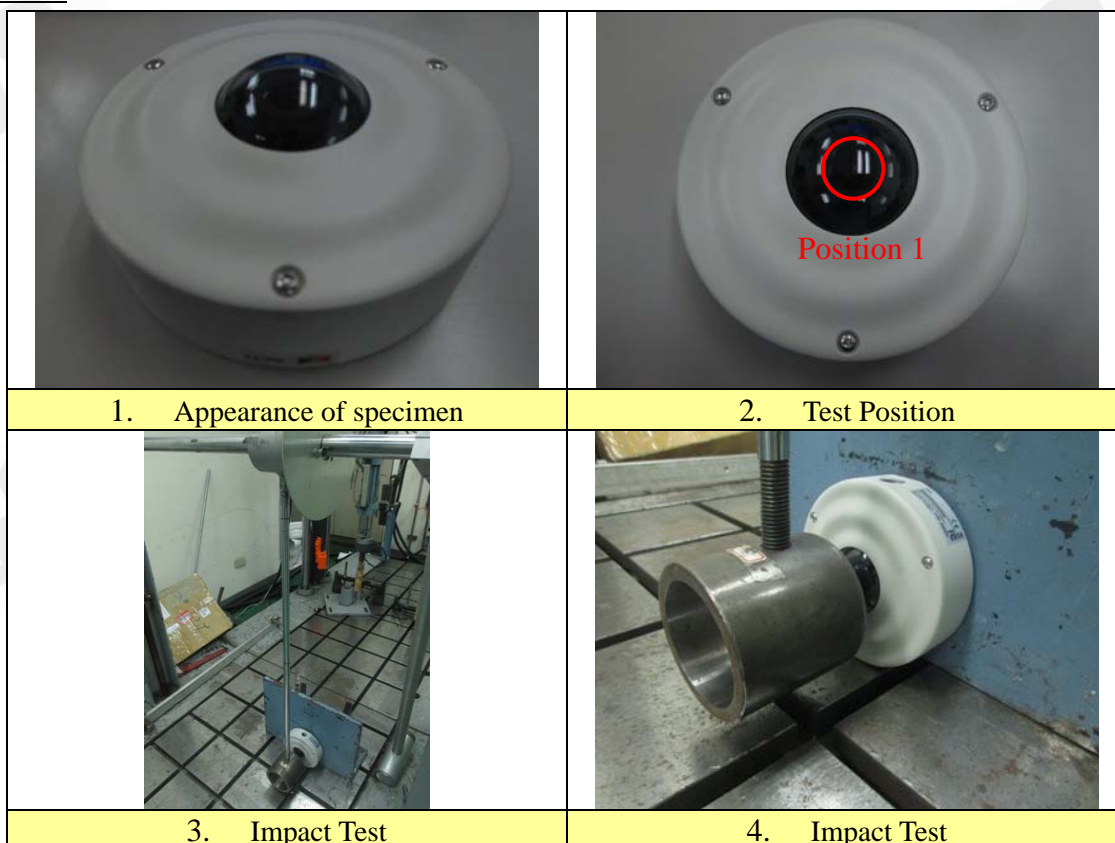
### Test Photos:

Lab Environmental Conditions:Ambient temperature:  $(25 \pm 3) ^\circ\text{C}$ Ambient humidity:  $(55 \pm 20) \% \text{ RH}$ Test Method/ Specification:Test method: Reference to IEC 62262 Edition 1.0: 2001--IK10Impact energy: 20 JouleMass: 5 kgImpact height: 40 cmTest Position: Position 1 (see photo 2)No. of Impact: 3 impacts/ position 1Testing device: As shown in photo 3, 4

Check Item Style/ Item No.	Appearance check (visual check)
I71/ No.1	No visible damage
